# Pintakasi

A REVIEW OF SHELTER/WASH DELIVERY METHODS  
IN POST-DISASTER RECOVERY INTERVENTIONS

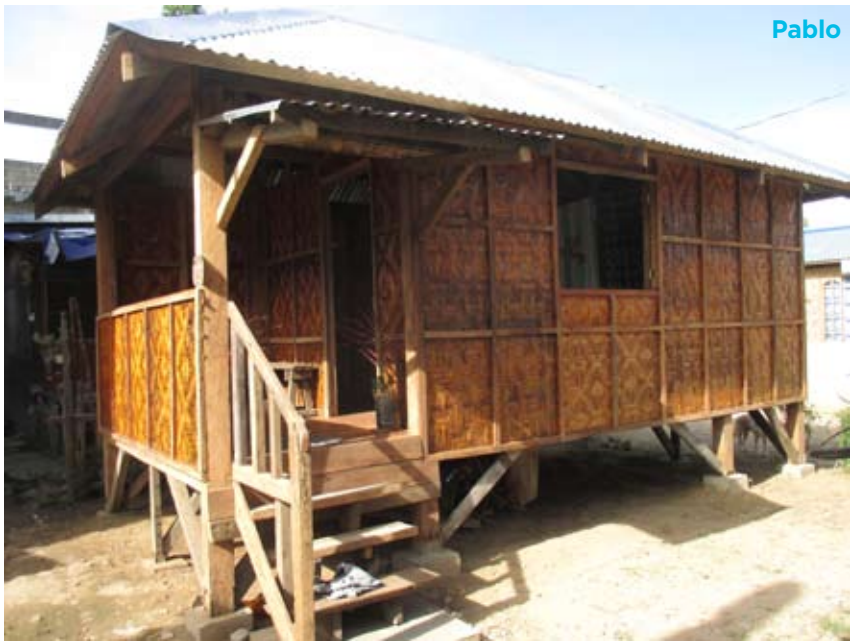
**Pablo**

Left: The Pablo style (named after Typhoon Pablo which hit the island of Mindanao in 2012) is elevated 0.6 meters above the ground with a concrete footing and uses woven bamboo mats (known locally as *amakan*) for walling.

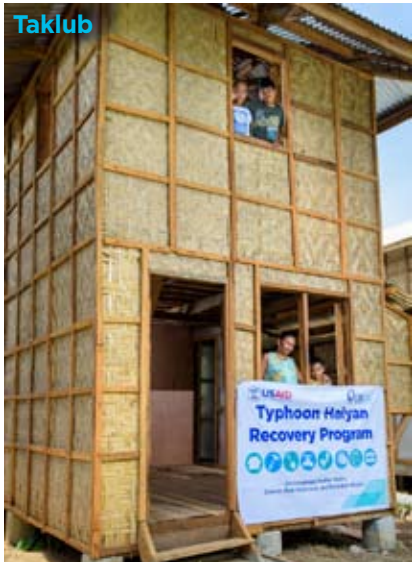
**Taklub**

Above: The Taklub—from the Waray Waray word *Tarakluban*, Tacloban City’s old name—was developed during this response and is a two-story model with a kitchen, adapted from the Pablo elevated style. *Taklub* is fishing gear used by fishermen and, in the local dialect, means “cover”.  
 Left: The Bohol (named after the earthquake which hit the island of Bohol in 2013) has a 0.6-meter base made from concrete hollow blocks and walls made from *amakan*.

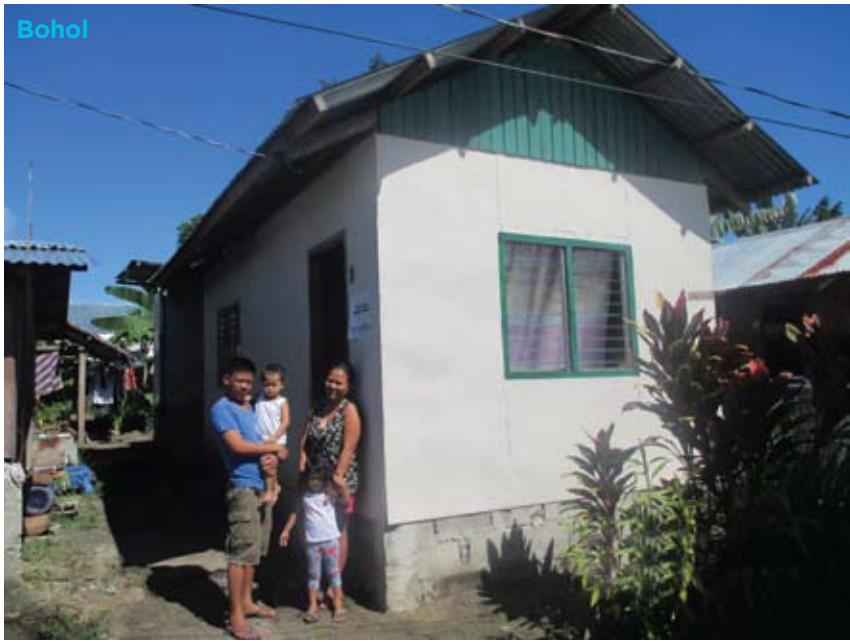
**Bohol**

The direct-build option—delivering shelter materials and providing skilled labor under the supervision of CRS engineers—was also used if local markets were not conducive to market-based solutions or if road accessibility was limited. Carpenters and foremen were trained in disaster-resilient construction techniques based on safe, adequate and durable shelters<sup>4</sup>. These included eight “build back safer” principles for the construction or repair of each shelter and/or toilets included guidance on site construction, shape, foundations, tie-down, bracing, joints, roofing, and preparedness.

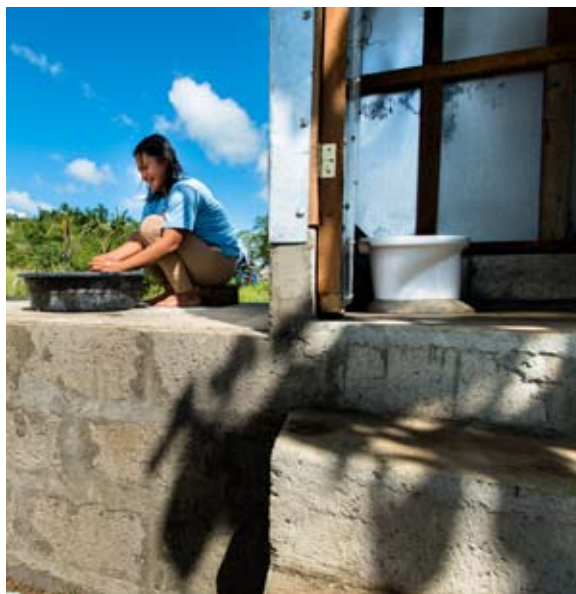
**Left: The Type 6 toilet and septic tank is for households whose groundwater level is higher than 0.65 meters from the natural ground.**

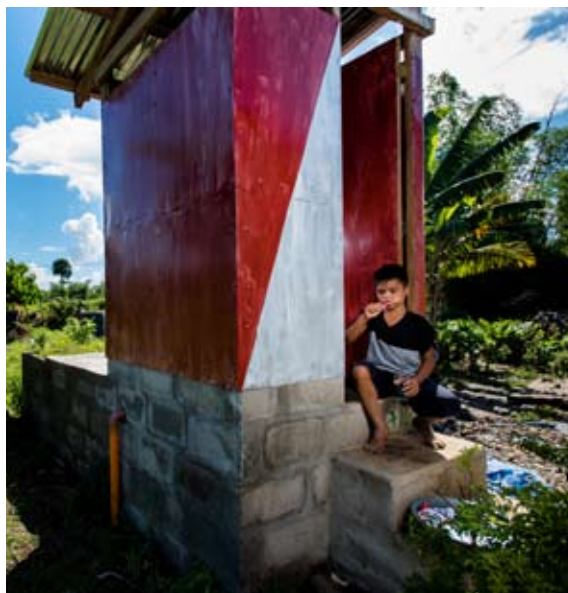
**Below: The Type 7 toilet and septic tank is for households whose groundwater level is between 0.65 and 1.5 meters from the natural ground.**

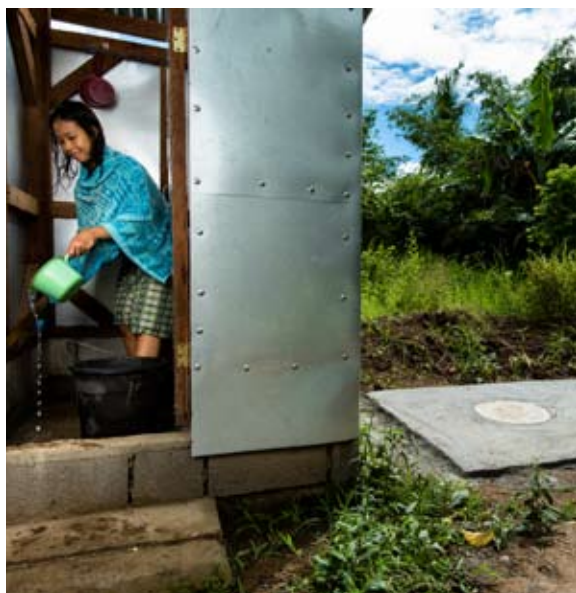
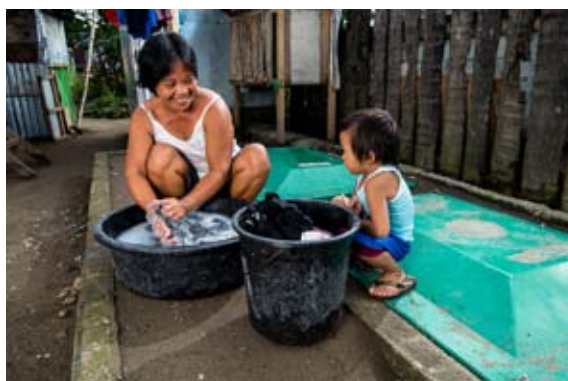
**Above left: The Type 8 toilet and septic tank is for households whose groundwater level is below 1.5 meters from the natural ground. Above right: Anaerobic baffled reactors<sup>5</sup> were used for clusters of households where there was not enough space to build individual septic tanks.**

5. Anaerobic baffled reactors (ABRs) are improved septic tanks that use baffled walls to help channel the water through active sludge resulting in improved wastewater treatment. CRS partnered with the Bremen Overseas Research and Development Association to manufacture ABRs using fiber-reinforced plastic so that they were portable and could withstand a high water table and flood-prone conditions

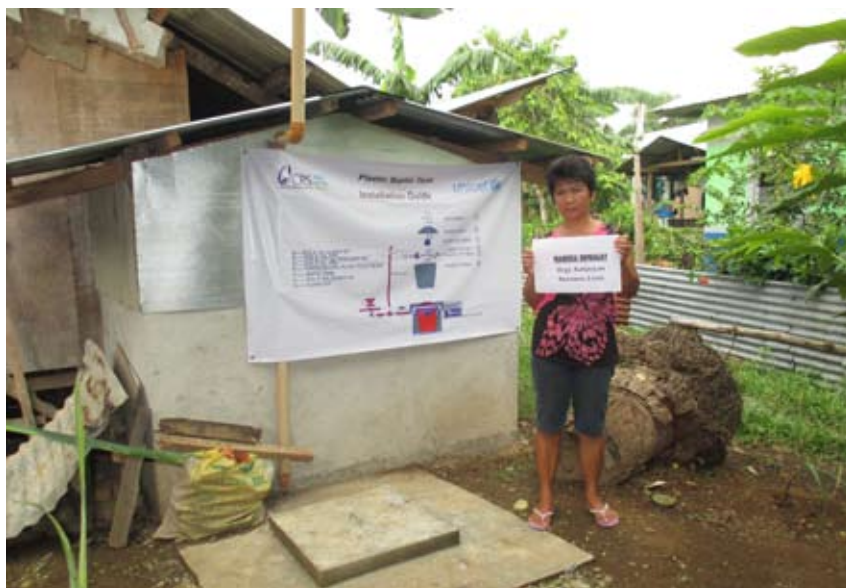
CRS engineers constructed a demonstration toilet in each *barangay*, showcasing the correct way to construct a septic tank using mock-ups and actual model construction.

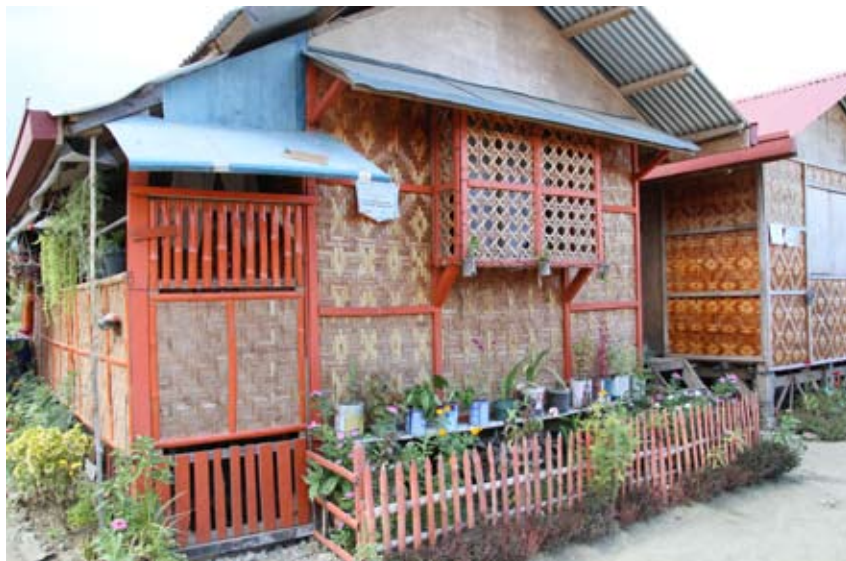
**CRS directly built shelters in four transitional relocation sites. Many households have already extended or modified the direct-build designs to fit their needs and preferences.**

The transitional relocation sites also included a full package of potable water from tap connections, electricity, rainwater drainage, rainwater collection gutters and barrels, and community spaces (basketball courts, playgrounds and multi-purpose halls).

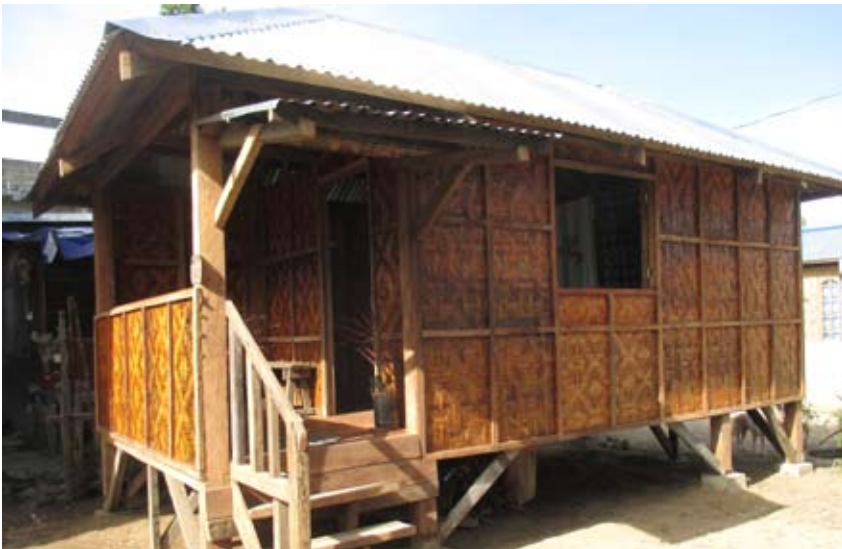
In December 2014, CRS changed the roof on the Pablo direct-build shelters from a gabled roof to a hipped roof.

In December 2014, CRS shelters and toilets were put to the test twice: Category 2 Typhoon Ruby with wind speeds of up to 100km per hour and Tropical Storm Seniang whose heavy rainfall flooded communities across Leyte and Samar. Very few of CRS shelters were damaged but the high level of flooding during Tropical Storm Seniang prompted some program managers to discontinue the use of one of the recommended designs, the popular Bohol style. The Bohol style was not elevated and had a base of concrete hollow blocks. This also prompted the adoption of the “hipped roof” design, previously piloted in the program areas, for all CRS direct builds. CRS engineers also encouraged households receiving cash to adopt the stronger hipped roof design with four sides, which some beneficiaries did even though the cash received was not enough to build this type of roof.

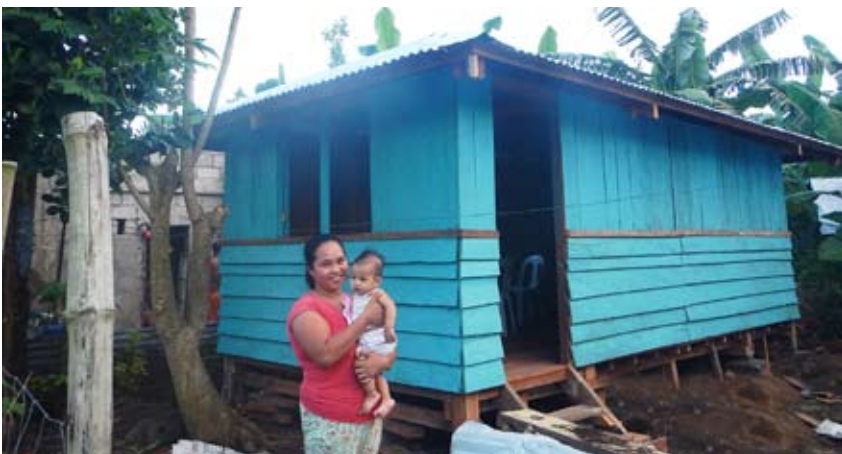
CRS piloted the use of coco lumber walling to replace the *amakan* bamboo walling in response to community feedback.

In August 2015, CRS piloted the use of coco lumber panels for walling in the direct-build shelters to respond to community feedback on the use of *amakan* bamboo walling. Beneficiaries felt the *amakan* bamboo walling was of a poor quality, could be seen through at night and let the rain in. The use of the coco lumber panels did not increase the price of the direct build.
